# 17-year-old Warehouse Worker Crushed by Forklift

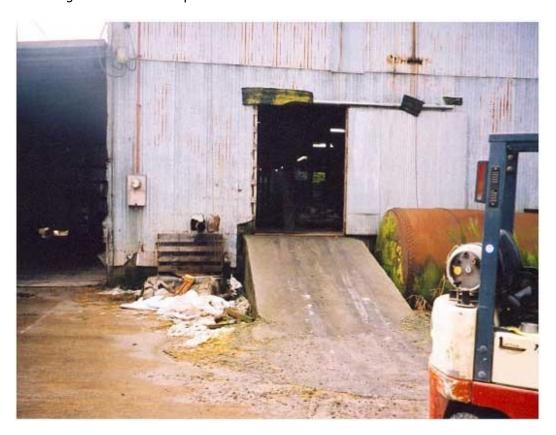
The incident happened at an agricultural cooperative (co-op). The co-op's retail store was connected to the co-op's tire shop and a warehouse. Also, on the grounds was an equipment storage shed, a fertilizer shed, and an outdoor storage area where 200-pound molasses animal licks were stored. A large flat concrete parking lot extended in front of the store entrance and around one side of the warehouse where a loading dock and ramp were located — Photo 1.

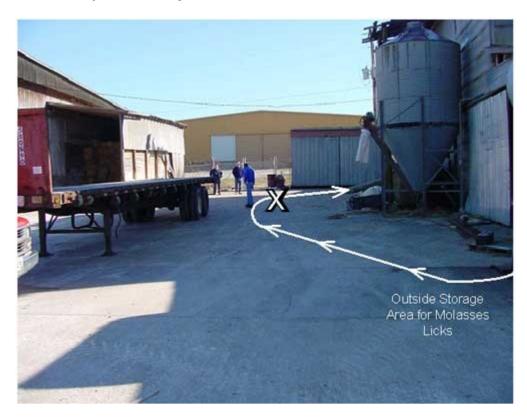
It appeared the victim was traveling toward the warehouse ramp on the level surface of the parking lot and made a sharp right turn to enter the narrow ramp leading up to the warehouse. It is surmised this is when the forklift tipped over onto its left side. The forklift was not loaded but its forks were raised approximately 20 inches. There was a single 12-foot skid mark located on the parking lot where it is surmised the victim started into a right turn toward the ramp.

Photo 2 illustrates the parking lot, warehouse and ramp, and other co-op buildings. Lines on the photo approximate the travel path of the forklift on the day of the incident. An "X" marks the approximate location of the forklift that had tipped over. Photograph courtesy of the Tennessee Department of Labor and Workforce Development, Division of Occupational Safety and Health.

The entrance/exit of the warehouse was narrow, measuring 70 inches in width. A post and an abandoned grain feed dispersal bin located inside the entrance left just enough room for the forklift to pass through.

- Old scrape marks on the forklift and on the post and grain bin inside the warehouse were likely indicators of a tight fit.
- The local manager said that forklift operators had to speed up to make it up the ramp and then had to slow down at the entrance to fit through the narrow passage after passing through the warehouse door.
- The ramp's surface was patched and rough where the ramp joined the flat, level parking lot.
  - The co-op was being relocated so the rough pavement in the transitional area where the level parking lot met the ramp, and the confined areas in the warehouse had not been changed because of the planned move.
  - It is worth noting these issues were known and identified as problematic.
- A well-developed safety and training program were lacking.

- Conduct periodic inspections and frequently remind equipment operators to use seat belts provided and never try to jump from an overturning sit-down type forklift.

- Check travel routes used by forklifts are free of obstacles and other unsafe conditions.
- Establish work policies that comply with child labor laws prohibiting youths less than 18 years of age from performing hazardous work, including operating power-driven hoisting equipment such as forklifts. All employees should be aware of this policy.
