# 17-year-old Warehouse Worker Crushed by Forklift

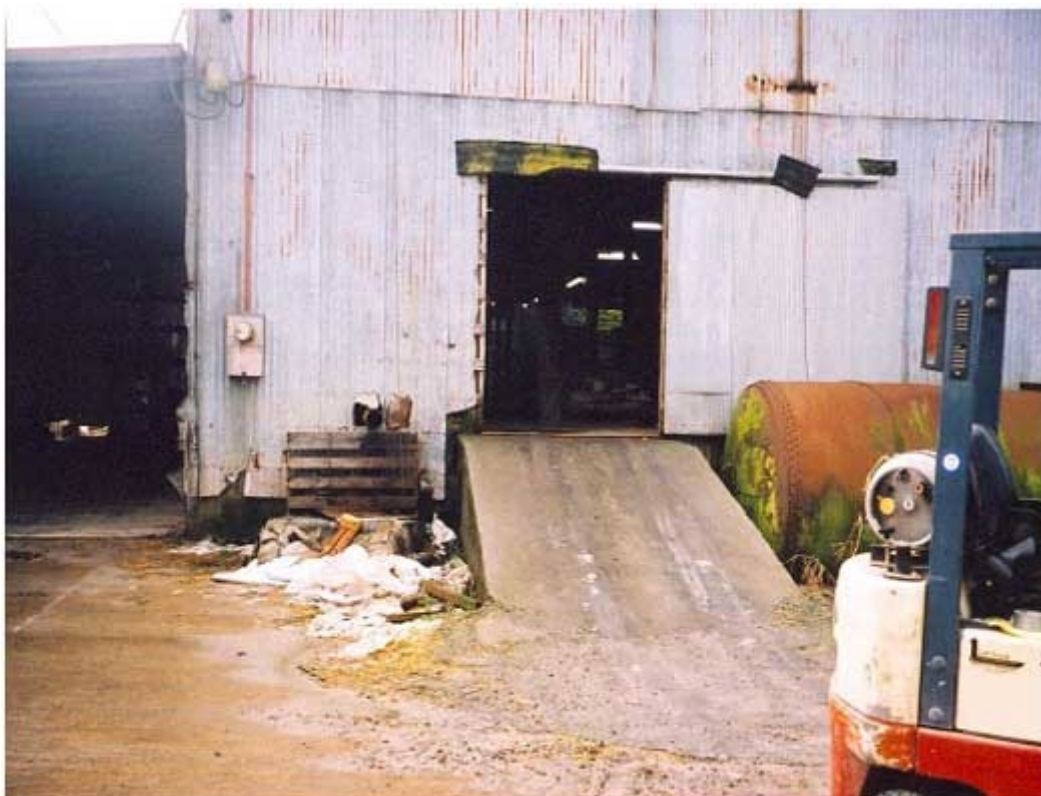
## Photo 1

The incident happened at an agricultural cooperative (co-op). The co-op's retail store was connected to the co-op's tire shop and a warehouse. Also, on the grounds was an equipment storage shed, a fertilizer shed, and an outdoor storage area where 200-pound molasses animal licks were stored. A large flat concrete parking lot extended in front of the store entrance and around one side of the warehouse where a loading dock and ramp were located – Photo 1.
