# Counterweight Gives Way

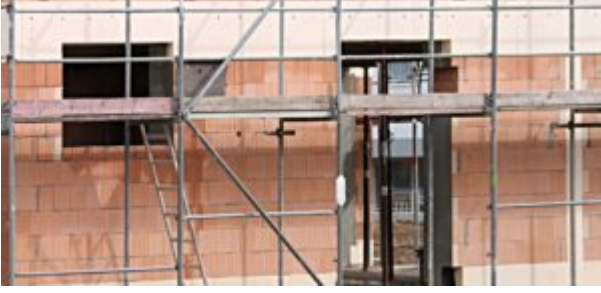
Two employees were painting the outside of a three-story building. They were standing on a two-point suspension scaffold. The outriggers for the scaffold were inadequately counterweighted with three five-gallon (18.93-liter) buckets of sand. They were not secured to a structurally-sound part of the building. Neither worker was wearing approved fall arrest equipment. One of the two outriggers failed. One painter was able to climb onto the roof but the other fell about 35 feet and was killed.

*Scaffolds and their components should be able to hold at least four times the maximum intended load. Outriggers must be connected to a structurally sound part of the building as a backup anchorage. Workers at heights must use approved fall arrest equipment with an independent lifeline also attached to a structurally sound part of the building.*
