# Crushed-between Scissor Lift and Support Beam

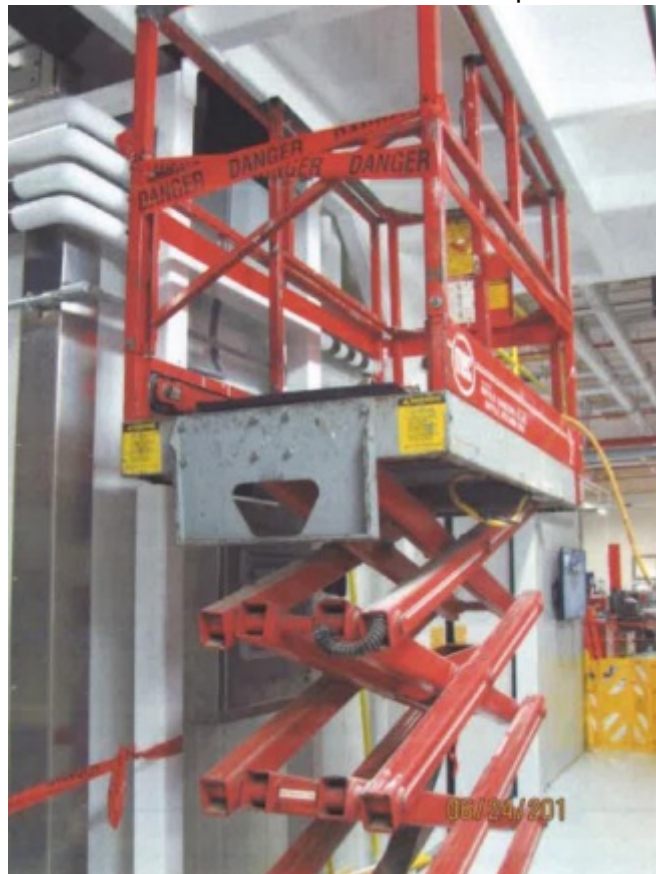
At some point while installing the insulation the victim became pinned between the

scissor lift upper guard rail and the bottom of the mezzanine outer support beam. During the investigation, it was determined that the control console on the scissor lift was missing the guard that prevents the

inadvertent activation of the lowering and rising of the work platform.

The control console was found hanging on the opposite side of the lift from the victim's work position. The most likely scenario is that the victim contacted the unguarded control console with his foot while trying to position himself leaning backwards out of the lift.

Had the guard been in place on the control panel and the victim not been working alone, it is likely this incident would have had a much different outcome. However, during the inspection it also was found the lower controls on the lift were not functioning, so it's possible that even if someone else was present they may not have been able to move the lift and free the victim in time.

This incident also highlights the importance of preventative maintenance and removing damaged or defective equipment from service until they are repaired or replaced.
