# Worker Electrocuted While Repaving Highway

A 44-year-old transportation worker died after being jolted with 7,200 volts of electricity while repaving a highway in Colorado.

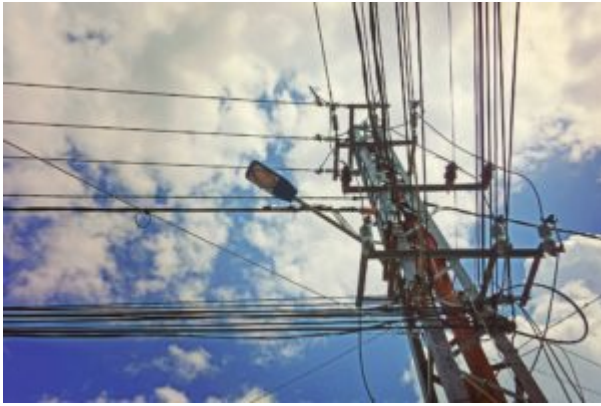
Rodger Bell was working on the back of an asphalt spreader, or lay-down machine, when he was jolted with electricity. It was reported that a truck dumping asphalt into the spreader came into contact with an overhead power line. Apparently the truck shifted when the load emptied out, and the raised dump bed moved forward to touch the wire.

The power traveling through the truck was so great that the tires exploded, and the asphalt beneath melted and turned to glass. The electricity also traveled through the spreader, which was in contact with the truck, shocking four employees. Three received minor burns and injuries, but Bell was critically hurt. He was taken by helicopter to an Albuquerque hospital, and died that night.

*If you can see a power line, keep well clear of it. Equipment operators have to be especially careful. If you're digging, there are power lines in the ground. If you're raising a boom, crane or cherry picker there are wires in the air. To stay safe, here are some easy precautions you can take:*

- Know where they are: Look for power lines when you start work.*
- Ask the utility company to shut off power or insulate the wires while you're working.*
- Maintain a minimum distance of 10 feet (3.5 meters) from power lines.*
