Crane Oiler Crushed

A crane oiler was crushed between counterweights and the superstructure (base) of a rotating mobile crane.

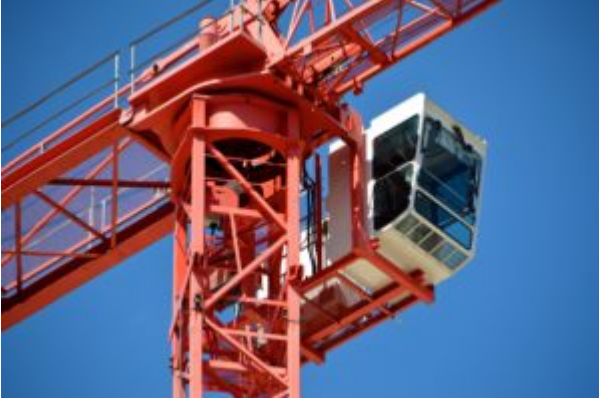
The victim and the crane operator had a habit of rotating the crane while the victim was not clear of the superstructure. This unsafe practice allowed the victim to signal when crane and counterweights were aligned. On the fatal day, they made eye contact as usual, then the operator turned to the controls.

Without communicating his intention, the victim climbed up on the crane. The investigation suggests he may have removed a shackle left on the counterweights. As the operator swung the crane around, he heard an unfamiliar noise. When he looked, he saw the victim was caught. The operator ran to check on him, then back to the controls to move the crane off him.

To communicate, do you and a co-worker rely on a nod or glance? This system may work as long as conditions don't change. In this fatality, the victim left his usual position. He could have communicated his intention if they had been using two-way radios or other such signaling devices.
