# Fall Protection Gone Bad

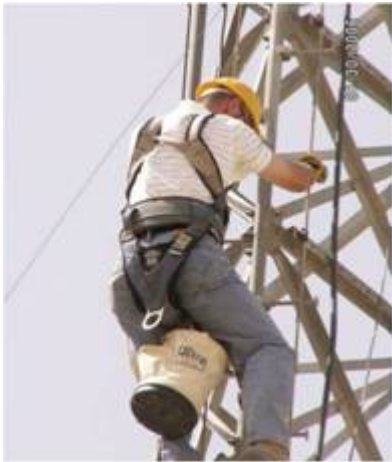
Can you tell what dangerous and illegal action the worker is engaging in?

The good news: The worker scaling this elevated structure is using personal fall arrest equipment. The bad news: His body harness is *upside down*—the D ring should be positioned at the center of his upper back, not below his behind!

**The Moral:** It's not enough to equip your workers with the right fall protection equipment. You also need to ensure they're trained to use it properly on the job.
