Football Jersey Gets Caught in a Conveyor Belt

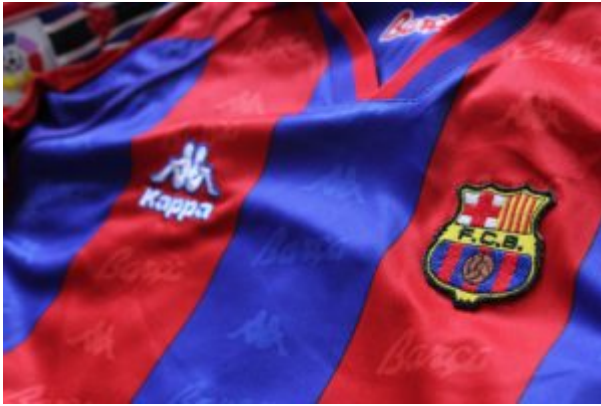
There was no sign of life in the worker and it took some time to release him from the rollers. His right arm was under his body and caught in the tailspool; his left arm crossed his body and was between the other roller and the belt. His shirt was wrapped around a spool and his glove was found in the second roll around the same spool.

Investigation revealed that it was likely the worker left the conveyor running instead of following the correct safe operating procedure of shutting off the conveyor belt while shoveling debris onto it.

His loose fitting football jersey caught between the belt and the tailspool and he reached with his hand to pull it out. His arm was then pulled under the spool, he was flung forward and hit his head, resulting in death.

Several factors contributed to the death of this worker. One was failing to follow safety instructions. The other was the loose fitting football jersey he was wearing. Unfortunately it took the death of this worker for this company to initiate rules against wearing loose clothing throughout this plant.

Procedures for working safely around machinery are in place for your protection. The rules against wearing loose-fitting clothing, unrestrained long hair or jewelry are there to prevent incidents like this one.
