Scaffold Tower Safety Picture This

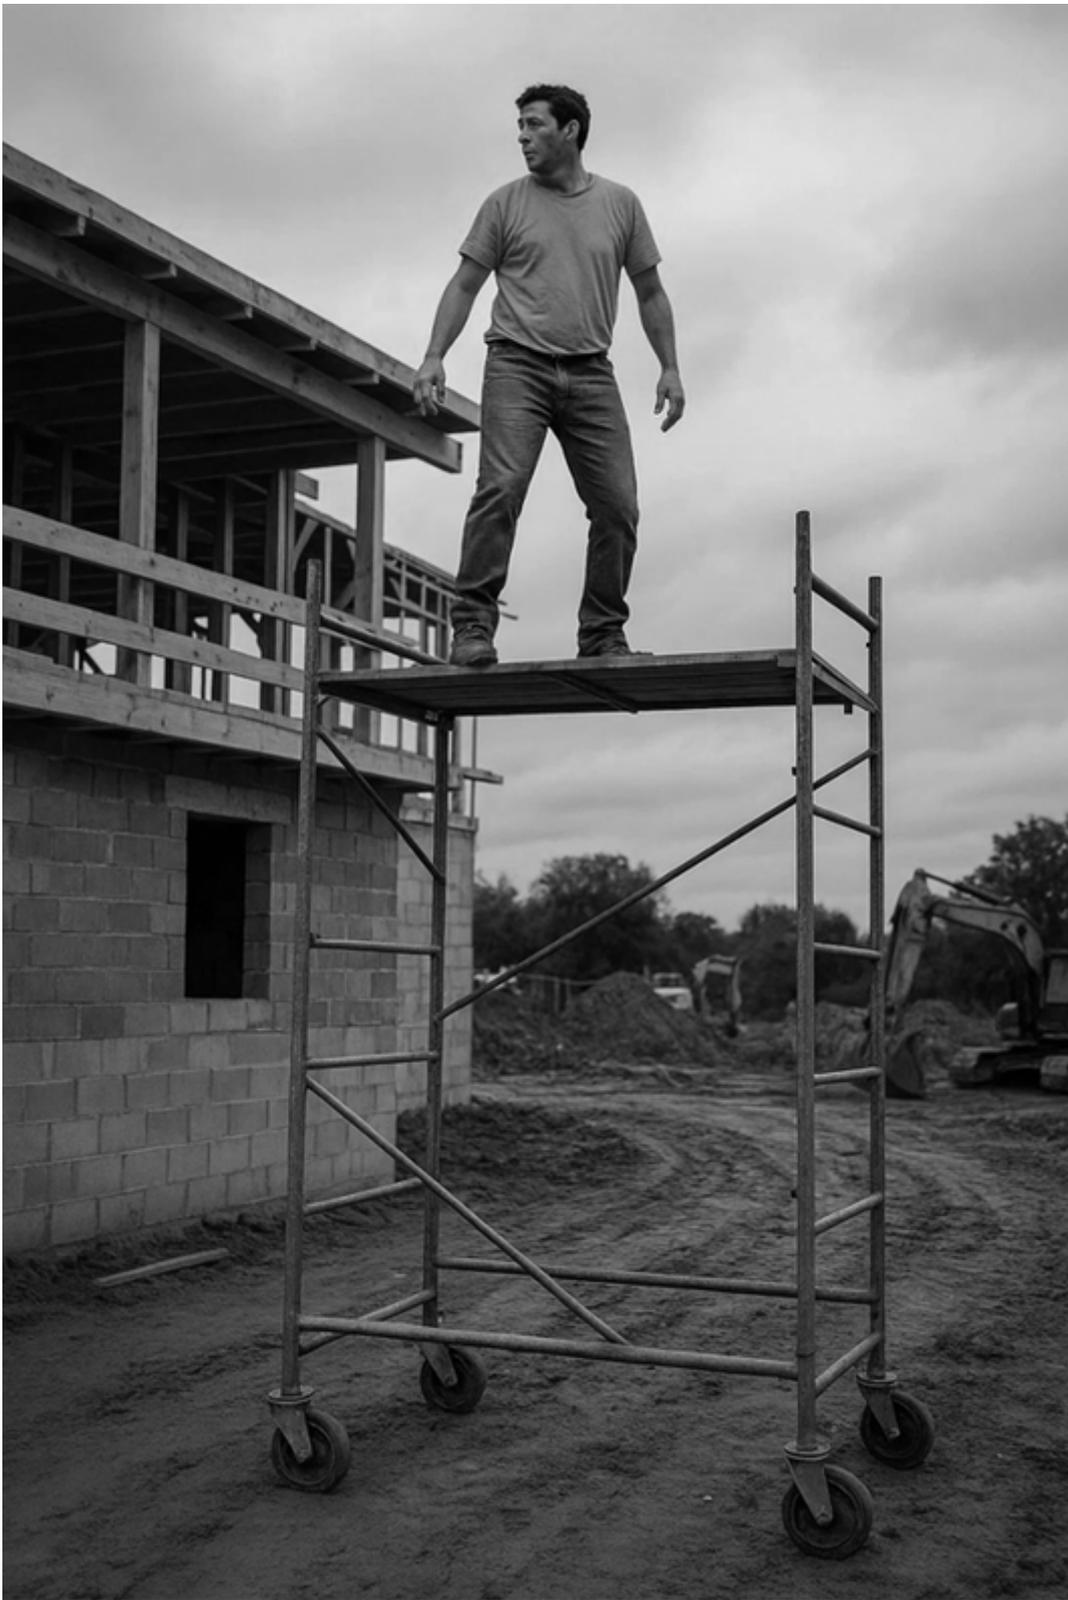
This image highlights a major scaffold tower safety issue. The individual is standing on a scaffold platform without any guardrails, fall protection, or visible stabilization. Additionally, the scaffold has wheels and appears to be unsecured, which increases the risk of movement and collapse. Working at height without proper precautions puts workers at serious risk of injury or death due to falls.

Scaffold towers must be equipped with guardrails, toe boards, and be properly locked in place, especially when used on uneven or soft ground like a construction site. Workers should also use personal fall arrest systems when required and never climb or work on a scaffold unless it's been inspected and deemed safe. This scenario demonstrates poor planning and non-compliance with basic scaffold safety standards.
