# Upper Boom Failure on Aerial Lift

## Incident Summary

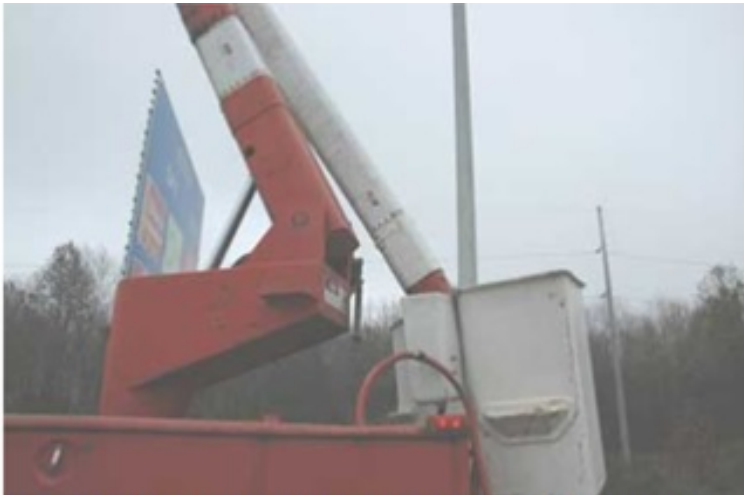
A 45-year-old owner of an electrical contracting company died after falling 9 feet to the road when the articulating boom of the aerial lift truck he was working from collapsed (photo 1).

**Photo 1: Aerial lift boom after incident. Note that the lower boom section remains elevated while the bucket-end of upper section is in a lowered position (photo courtesy of OSHA).**

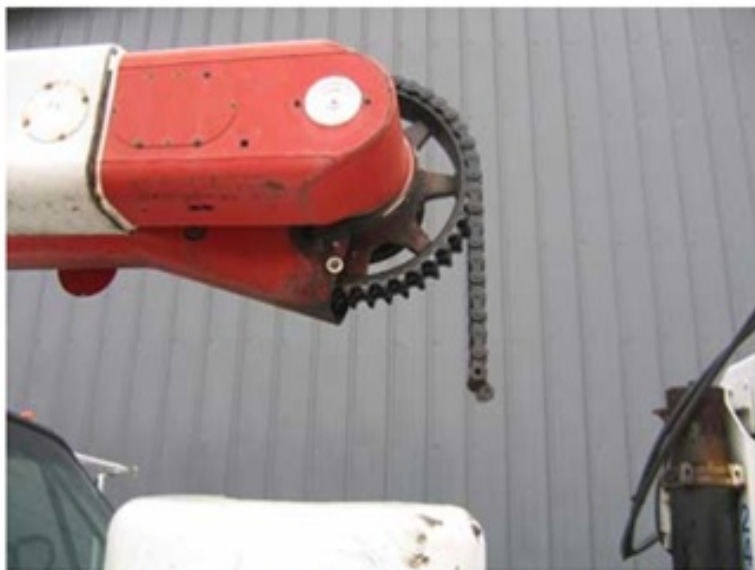
Post incident inspection of the articulating boom revealed the boom actuating chain had separated resulting in the catastrophic collapse of the upper boom (photo 2).

Photo 2: Broken boom actuating chain (photo courtesy of OSHA).

It appears lack of proper lubrication of the chain is likely what caused the chain to break. This incident highlights the significance of:

1. Reading and adhering to the manufacturers’ recommended maintenance schedule. The operation and maintenance manual detailed maintenance recommendations, procedures and warnings.

3. Regular maintenance and inspection by a qualified person.

- The operation and maintenance manual recommended regular maintenance and inspections to include – the upper boom actuating chain for lack of lubrication, broken rollers and pins.
- It also stated lack of lubrication is indicated by squeaking or groaning noises when the booms are moved.
- The recommended inspection/maintenance frequency for pulleys, sprockets, pins and chains is monthly. A major overhaul of the unit was recommended, according to average use, after 3 years or 6,000 hours of use, whichever came first
  - The aerial lift involved in this incident was 18 years old.
  - There was no record of maintenance and inspection having been performed on the boom structure or other assemblies of the aerial lift.

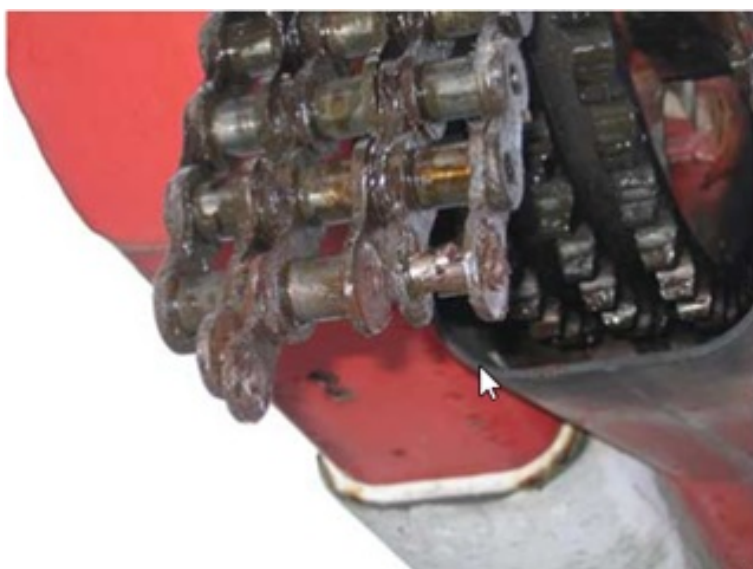
- In particular, the manufacturer recommended the roller chains, including the upper boom actuating chain, be lubricated every 30 days.
- A warning in the manual stated a lack of lubrication can cause galling and corrosion of the chain pins; breakage of the pins; and result in free fall of the upper boom (photo 4).

Photo 4: Broken section of boom actuating chain  
(photo courtesy of OSHA).
