# Welder Struck by Forklift

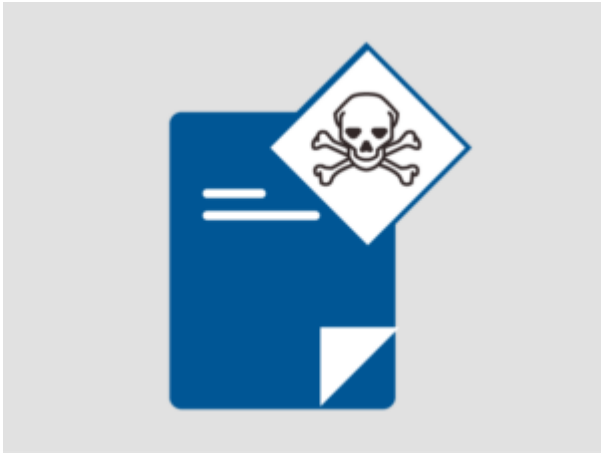
A worker driving an electric cart was run over and crushed by a forklift driver who could not see past his tall load.

The incident occurred at a concrete pipe manufacturing plant where the man worked as a maintenance welder. The man and a co-worker were travelling west in the electric cart with a load of oxyacetylene and electric arc welding units when a forklift travelling in the opposite direction turned into them. Both men in the cart were thrown to the ground. One received only cuts and bruises. The other man was run over and his torso was crushed. He was pronounced dead at the scene. Poor visibility was a significant factor in this incident. The electric cart had no warning flag to increase its visibility and a high load obscured the forklift driver's view.

*Protect yourself and those around you by ensuring you can see and be seen while operating motorized equipment including forklifts and electric carts. Drive forklifts with the forks as low to the ground as is safely possible and ensure electric carts are equipped with a warning flag to improve visibility. Speak to your employer about the installation of seatbelts and rollover protection in electric carts. If a collision occurs, rollover protection can protect both the driver and passenger.*
