Upper Boom Failure on Aerial Lift

Incident Summary

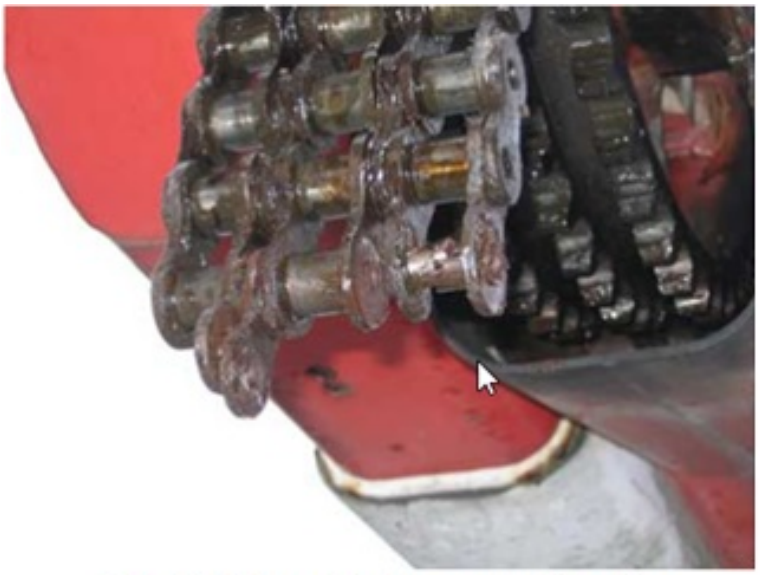
Post incident inspection of the articulating boom revealed the boom actuating chain had separated resulting in the catastrophic collapse of the upper boom (photo 2).

It appears lack of proper lubrication of the chain is likely what caused the chain to break. This incident highlights the significance of:

- In particular, the manufacturer recommended the roller chains, including the upper boom actuating chain, be lubricated every 30 days.
- A warning in the manual stated a lack of lubrication can cause galling and corrosion of the chain pins; breakage of the pins; and result in free fall of the upper boom (photo 4).

Photo 4: Broken section of boom actuating chain (photo courtesy of OSHA).

1. Reading and adhering to the manufacturers’ recommended maintenance schedule. The operation and maintenance manual detailed maintenance recommendations, procedures and warnings.

2. Pre-use inspection and removing suspect equipment from service until has been made safe to use.

3. Regular maintenance and inspection by a qualified person.

- The operation and maintenance manual recommended regular maintenance and inspections to include – the upper boom actuating chain for lack of lubrication, broken rollers and pins.
- It also stated lack of lubrication is indicated by squeaking or groaning noises when the booms are moved.
- The recommended inspection/maintenance frequency for pulleys, sprockets, pins and chains is monthly. A major overhaul of the unit was recommended, according to average use, after 3 years or 6,000 hours of use, whichever came first
    - The aerial lift involved in this incident was 18 years old.
    - There was no record of maintenance and inspection having been performed on the boom structure or other assemblies of the aerial lift.
