Warehouse Supervisor Crushed by Pallet Stacking Machine

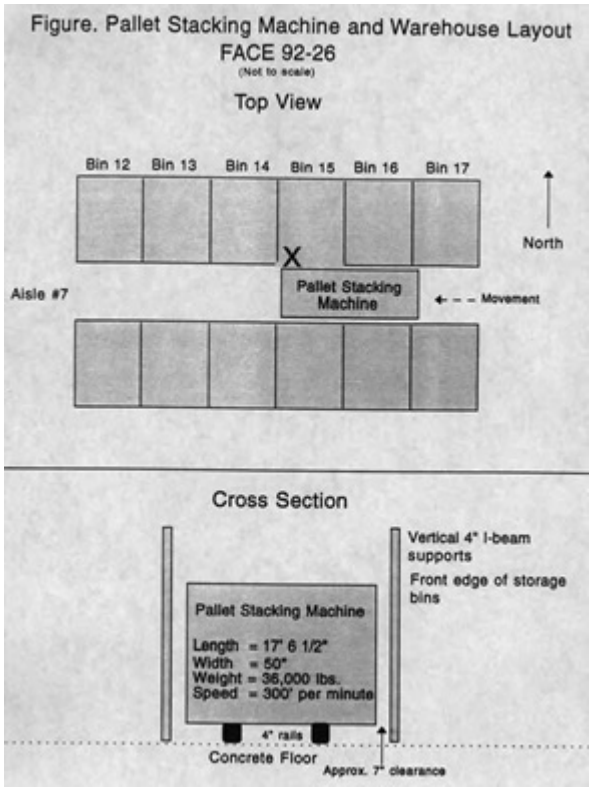
Victim

A 40-year-old experienced warehouse supervisor died when he was struck by a pallet stacking machine and crushed against a storage rack support.

For unknown reasons the victim was in the aisle and had his back to the approaching stacking machine. It struck and crushed him between the stacking machine's frame and the storage rack's vertical support I-beam. His body was dragged several feet until some part of the victim's body contacted the bumper, causing the machine to stop.

The medical examiner pronounced the victim dead at the scene. The cause of death was mechanical asphyxia due to crushing chest injuries.

The pallet stacking machine, which could be operated automatically or manually, was equipped with a switch that could have been locked out prior to entry into the aisles. Lockout was not performed in this case.

- Creation of specific procedures to follow prior to any work being performed in the aisles. Including:
  - Locking and tagging the machine in the off position when personnel are in the aisles.
  - Retaining the key until all work is completed and the aisles are clear of personnel.
- Consider using two workers to perform any work in the aisles. One worker would be responsible for monitoring the movement of the machine while the other worker performs the task.
  - If the victim hadn't been working alone it is possible the second employee

- Consider installing stationary aisle warning lights and redesigning the stacking machine’s pressure-sensitive stop bumpers.
    - Although the pallet stacking machine had green travel warning lights and pressure-sensitive stop bumpers located on the front and rear ends of the machine, the incident still occurred.
    - The warning lights may be effective when an employee is facing the machine, but in this incident the victim had his back turned toward the machine, apparently did not hear its approach and was struck and killed.

- Installation of stationary travel warning lights at conspicuous areas within the aisles.
    - Any time the machine is in operation, the stationary travel warning lights would illuminate to warn any worker in the area that the machine is in operation and to be alert to its location and movement.
- Redesigning the pressure-sensitive stop bumpers so an object located laterally, or adjacent to the machine, would contact the bumper causing it to stop.
    - The pressure-sensitive stop bumpers located on the front and rear ends of the machine, could only be activated by direct forward or rearward pressure on the bumpers.
    - An object which was positioned laterally, or adjacent to the direct line of travel (as was the case in this incident), would not engage the bumpers and stop the machine.
