Fall Through Temporary Roof Opening

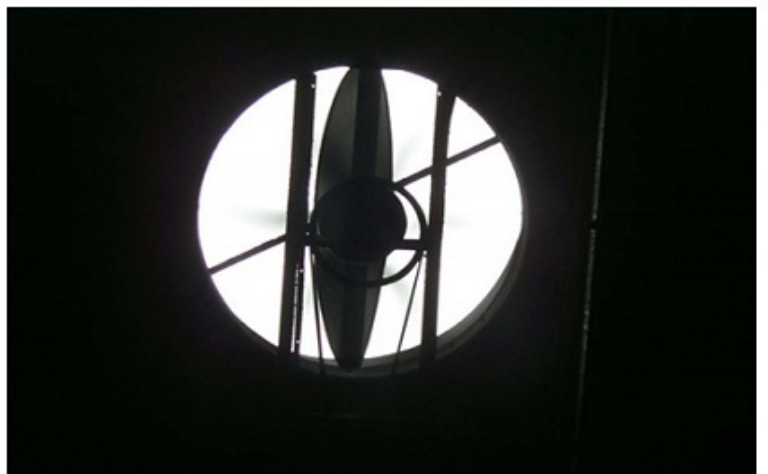
Exhaust fan above machinery on factory floor.

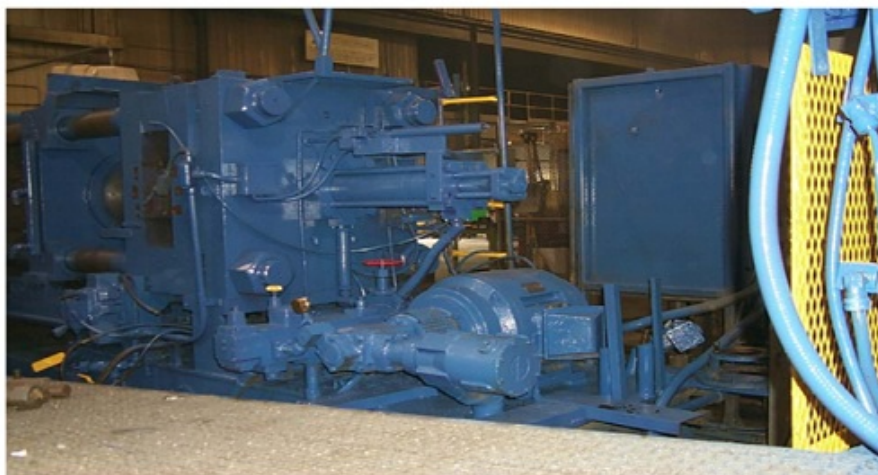
He fell onto a 1200-ton die-casting machine on the factory floor. Onsite personnel working nearby heard the cleaner fall onto the machine. They summoned help and factory-employed emergency response personnel responded to the scene, assessed the situation and called for an ambulance. Local emergency medical personnel and police

Machinery victim fell on.
