Fall Through Temporary Roof Opening

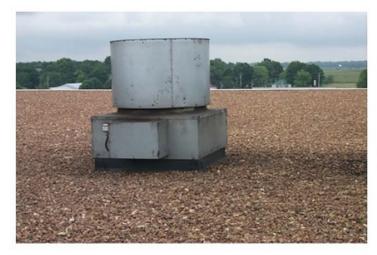
Exhaust fan had been removed for cleaning, creating a temporary opening where cleaner fell approximately 35 feet/10 meters onto a piece of machinery in the factory.

A 50-year-old male cleaner died when he fell approximately 35 feet through a temporary roof opening and was impaled on a piece of equipment on the factory floor below. He had been cleaning an exhaust fan with a pressure washer on the factory roof. He and two co-workers had removed the fan from its casing creating a temporary roof opening and set the fan beside the roof opening for cleaning.

Facing the fan with his back to the opening, the cleaner apparently stepped backwards and fell through the opening.

- 1. Openings in roofs, floors, and walls must be barricaded, protected with a guardrail system, or covered with marked covers to prevent someone from unintentionally falling through them.

- a. The employer stated that the factory initially did not want the holes covered up when the fans were removed because it would keep air from flowing out of the factory.

- b. After this incident occurred, the company constructed covers of $2 \times 4s$ and plywood nailed together to be placed over the temporary holes in the roof while the fans were removed.

- c. Additionally, a moveable four-wall, five-foot-high barricade could have been constructed for the roof openings. This would have allowed the factory air to exhaust through the roof openings while the fans were being cleaned.

- 2. Fall protection equipment must be worn when workers are performing work at heights. Properly used and anchored fall protection would likely have saved this man's life.

- a. Besides barricades around the roof openings, the laborers could have worn appropriate harness devices tethered to roof anchors.
- b. The roof of the building was flat and there are at least two types of roof anchors designed for use on flat roofs.

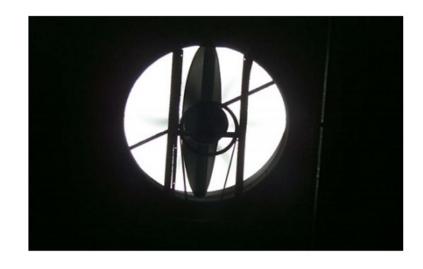
Exhaust fan above machinery on factory floor.

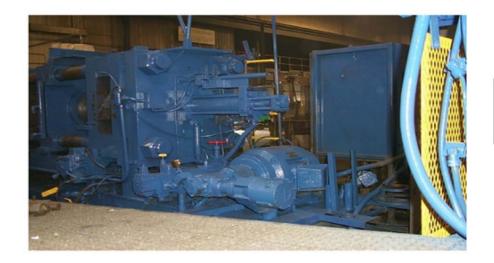
He fell onto a 1200-ton die-casting machine on the factory floor. Onsite personnel working nearby heard the cleaner fall onto the machine. They summoned help and factory-employed emergency response personnel responded to the scene, assessed the

Machinery victim fell on.
