# Bulldozer Skids Into Excavation

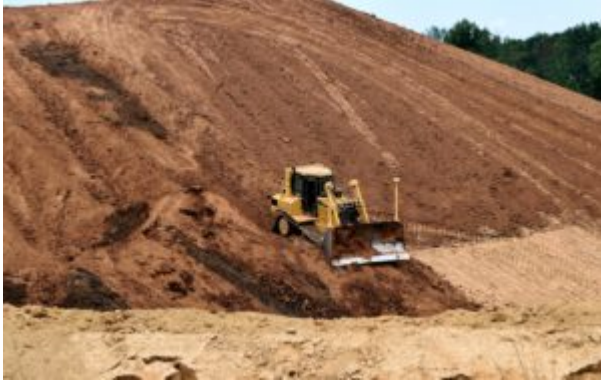
A worker was operating a bulldozer at the top edge of a sloped excavation. The trench was being developed for a drainage ditch six feet (1.8 meters) deep. The surface was covered with snow and ice, and the bulldozer slid out of control down the side of the excavation. It tipped on its side and pinned the operator under the rollbars. He was not wearing the required seatbelt, which would have held him inside the operator's cage and saved his life. Had the edge or the rim of the excavation been clearly marked with colored flag tape or another kind of warning, the operator might not have ventured too close to the edge.

*This fatality involved a bulldozer but it could as well have involved a car, truck, forklift, tractor or any other kind of mobile equipment. Seatbelts save lives in both high-speed crashes and low-speed upsets. Drivers of all vehicles must be able to recognize and avoid unsafe conditions such as the icy edge of this excavation.*
