# Buried in Sawdust

A worker died from suffocation after he was buried in a sawdust bin at a wood processing plant.

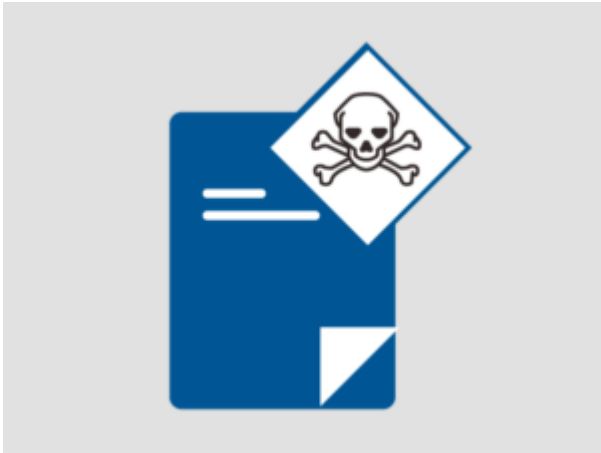
He had backed a truck under the bin and was attempting to load sawdust. The auger was turning in the overhead bin but the sawdust was not falling into the truck. So the worker climbed the ladder to the top of the bin and attempted to break the sawdust free with a length of pipe. When this was unsuccessful, he entered the bin without putting on the available lifeline. As he stepped on the crusted surface of the sawdust, it collapsed. He fell into the sawdust and was buried.

Sawdust continued to be blown into the bin from the adjoining wood processing plant during the several hours before the worker was reported missing. A supervisor entered the bin, also without the lifeline. He also sank into the sawdust but was rescued.

*Many factors contributed to this fatality. Standard confined space entry procedures should have been followed. Safety equipment should have been used for entering the bin of unstable material. A standby person should have been on duty to communicate with the worker in the confined space and to initiate a rescue. The coroner who conducted the inquiry also recommended a system of electrical interlocks should have been in place so the blower would not have continued to move sawdust into the bin while it was occupied. Also apparently lacking at the plant was a confined space permit system. Confined space work requires a written policy and continuing training.*
