# Cable Installer Electrocuted

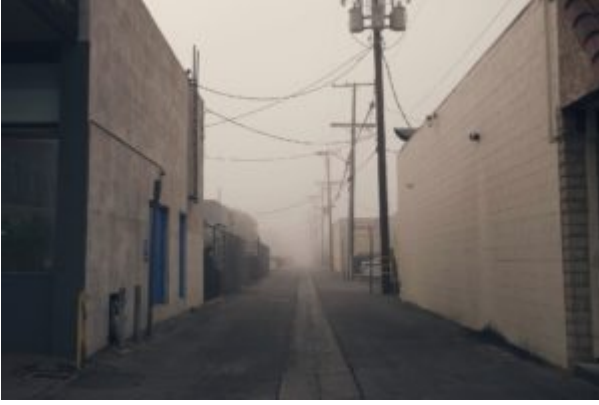
A cable television installer was working from an aerial lift bucket as he strung wires for television cable. He was using a saw to cut tree branches which were in the way. As he elevated the bucket to reach more branches, his head touched a 7,620 volt line. A co-worker saw the victim fall over, so he lowered the bucket. With the help of a police officer he attempted cardiopulmonary resuscitation, but the victim did not survive.

*When investigators looked at the conditions and events leading up to this fatal incident, they found no written record of safety training for this employee. Nor was the worker adequately protected by clothing or equipment. He was wearing a baseball cap instead of a non-conductive hardhat. He was not wearing a safety harness and lanyard to stop a fall. The aerial lift was not designed for work near power lines and it was being operated improperly within the 10 foot clearance.*
