# Electrical Hazards in Construction – Power Tools Picture This

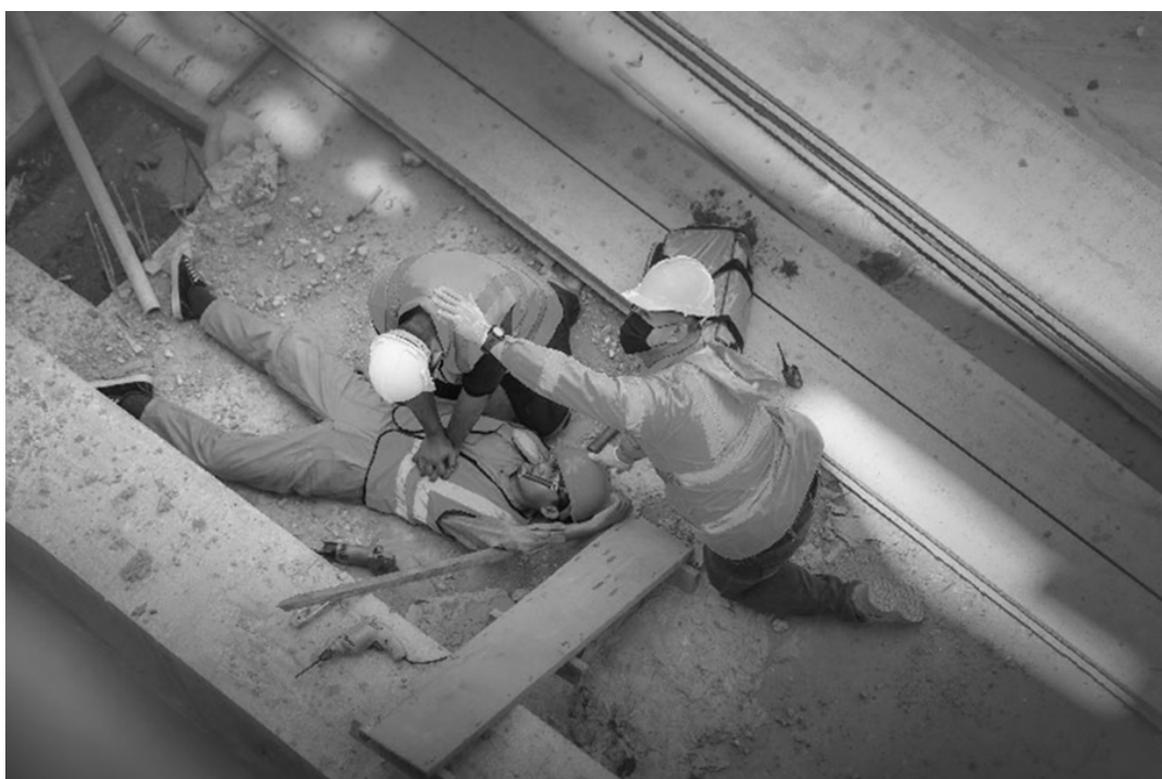
The worker is lying injured on a concrete surface, likely due to an electrical shock or fall related to unsafe tool use or exposed power sources. Tools are scattered on the ground and no barrier or warning signage is visible, indicating poor housekeeping and hazard control. There's no sign of ground fault circuit interrupters (GFCIs) or protective measures to prevent such incidents.

Ensure all electrical tools are properly maintained, grounded, and connected to GFCIs in wet or unfinished environments. Keep the workspace clear of obstructions, and use signage or barriers around hazardous areas. Provide thorough training in electrical safety procedures and emergency response to reduce injury risks.
