Is This a Safe Way to Guard a Floor Opening?

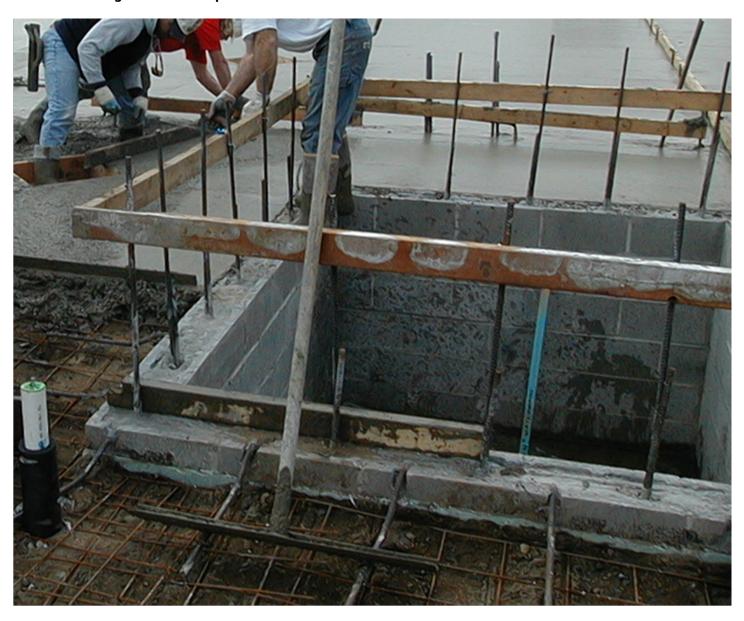
What is wrong with this picture?

The railing arrangement in this photo is in some ways more dangerous than the floor hole it's guarding:

• There's no intermediate railing; and

• The post ends jutting out from over the top railing are uncapped and could cause serious damage if workers stumble into them.

Moral: Make sure your floor hole guarding arrangements meet OSHA standards and don't expose workers to additional hazards.

The railing in this photo is clearly not up to "standard."

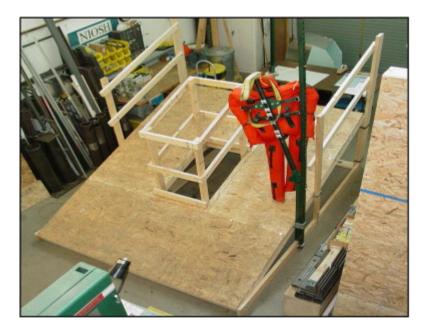
OSHA (Sec. 1910.23(a)(8)) says that floor openings must be guarded by **EITHER**:

1. A Floor Hole Cover of standard strength and construction;

0R

2. A Standard Railing and Toeboard on all exposed sides.
