Machine Guarding Hazards

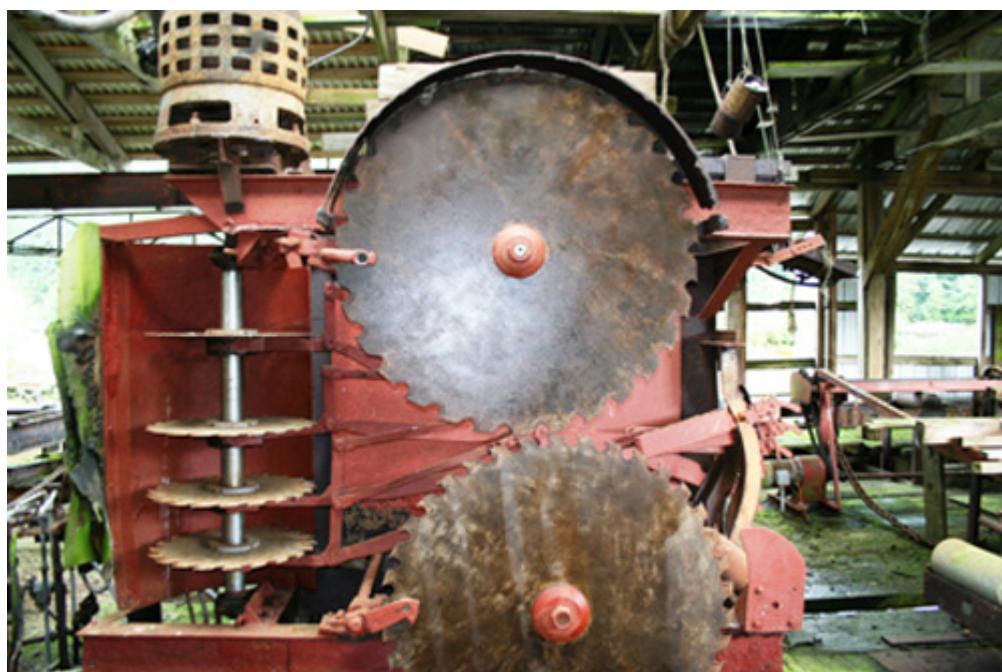
This double circular mill saw isn't properly guarded. Can you explain why?

These brutes are seven-foot saws in a double circular mill arrangement. And they're not properly guarded.

The Moral: According to the OSHA Sawmills standard, Sec.1910.265(e)(2)(iii)(c), the upper saw of a double circular mill must have a *substantial* hood or guard. The upper saw does have a hood but it sure doesn't look "substantial." The other problem is that there's no screen or other device in place to protect sawyers from flying particles as required by the standard.
