# Prevent Hoist Line Failure

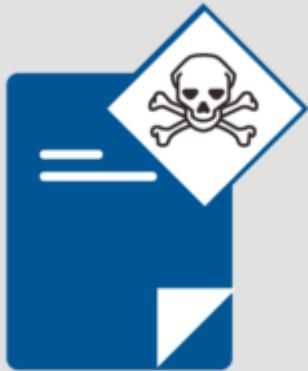
A derrickman was killed when a hoist line failed after the traveling block ran into the rig crown.

When the line failed, the traveling block fell, hitting the worker who was in the rod basket (below the rig crown).

A flag, attached to the drill line, was being used as a visual aid to stop the hoist when the flag reached the drum. A visual error allowed the block to run into the rig crown.

- Do not rely on visual references.
- Install an upper travel limit device to guard against line failure.
