# Two Lone Worker Deaths in 24 Hours

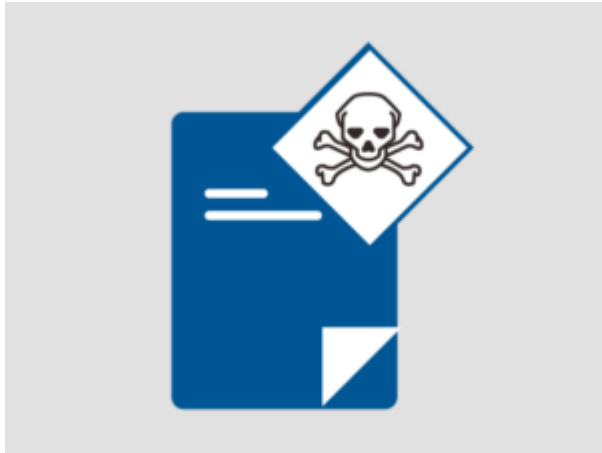
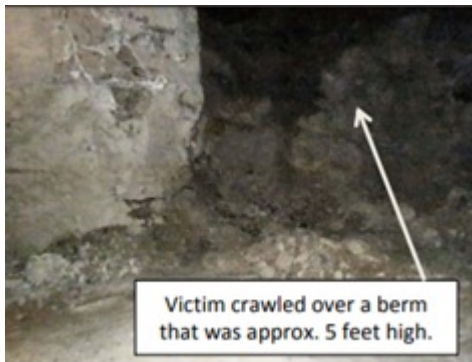
On January 25, 2017, a miner was found in an underground limestone mine after failing to exit the mine at the end of his shift. The miner was found under material that had fallen on him from a rib in an area of the mine that had been barricaded to prevent entry due to bad roof and rib conditions.

1. Never enter hazardous areas that have been barricaded or otherwise identified as unsafe to enter.
2. Develop and train workers on a method that clearly alerts them not to enter hazardous areas. Enforce this with disciplinary action if protocol/area is breached.
3. When possible, do not let workers work alone, especially in hazardous areas. If work must be done solo, set up a plan for communication.
4. Before any solo work is done identify known and potential hazards.
5. Never perform work on a moving conveyor belt or other moving equipment or

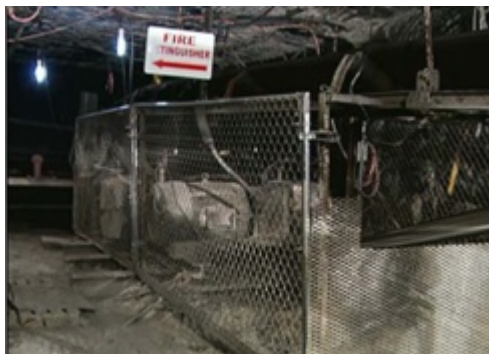
On January 26, 2017, a coal miner was discovered entangled at a conveyor belt drive, also after failing to exit the mine at the end of his shift. In both instances the victims were working alone and in restricted areas where there were hazardous conditions.

machinery.

6. Never perform work on any machine, equipment, or vehicle without taking following LOTO procedures – de-energize electrical power, lock and tag the disconnect with your lock and tag, and block parts that can move against motion.
