# Verifying Safeguards Picture This

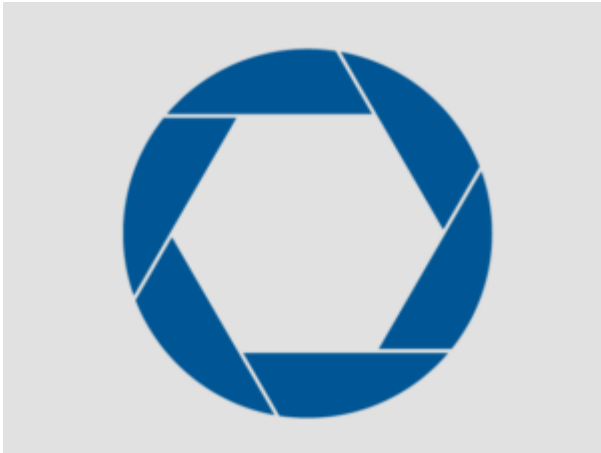
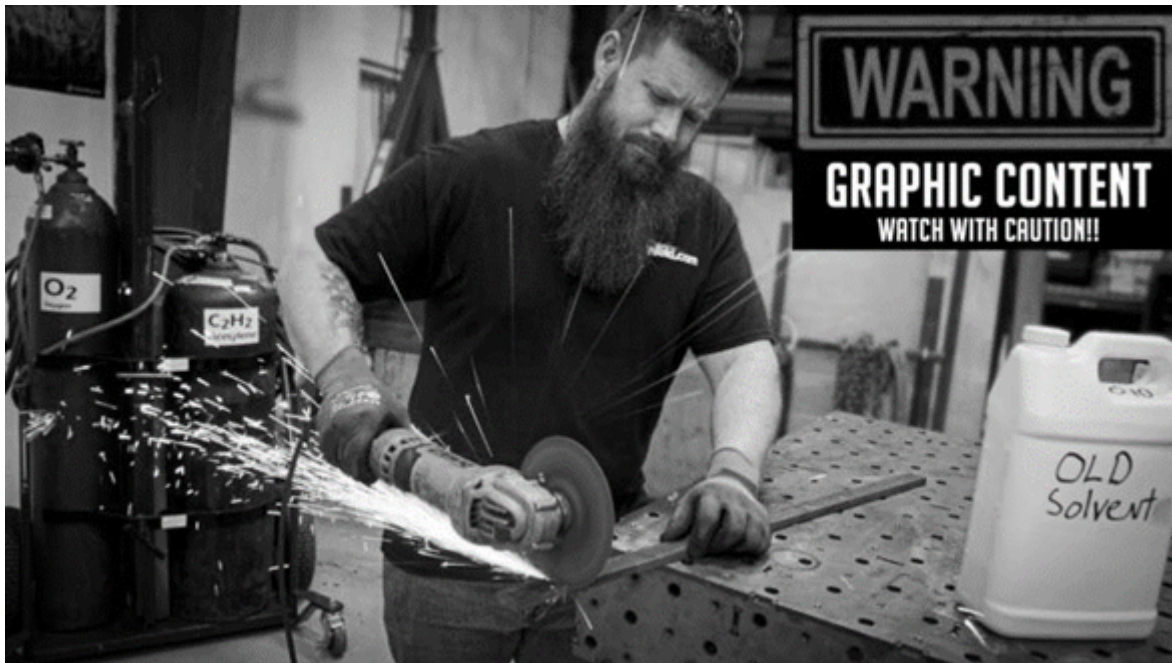
**What is wrong in this picture?** There is a man doing multiple unsafe procedures in this picture, first he using a grinding wheel without any guard, second all the sparks coming out of the machine are falling into two oxygen cylinders which makes it too dangerous, third he is not wearing any facial mask or glasses to protect his eyes from those sparks and finally there is a solvent knob close to his work area. All of those unsafe procedures are strongly dangerous that can result in a horrible disaster with many injuries, burns and even death.

Never use a machine without the guard which is provided for protection. Check the machine for any kind of crack or damage before using the grinder.

Never use a machine without wearing all the personal protective equipment and clothing such as goggles, helmets, masks, ear protection, gloves, leather aprons etc. Also ensure that the personal protective equipment and tools are in proper condition before using them.

Finally, make sure all safeguards are in place to avoid a catastrophe, check your work area before start working, follow all safety work practices and ensure your personal safety.
